Project Profile

The Richard L. Roudebush Indianapolis VA Medical Center, located 2 miles northwest of downtown Indianapolis, has been serving Indiana Veterans since 1932. The center receives referrals from VA facilities in Ft. Wayne and Marion, Indiana, and Danville, Illinois. Each year, more than 500,000 patients pass through the facility. Millions of dollars of high-tech medical equipment and critical care units are housed at the Roudebush Center.

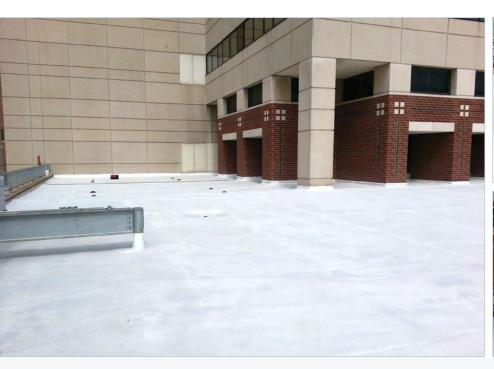
One of the most difficult aspects of this roofing project was the drainage. On top of requiring new slope, the roof had over 150 penetrations, most of these in the form of roof drains. Foam was the best tool available with regard to guiding water to the drains, and then creating a smooth, water-tight seal at the drains.

- Atlas ACfoam III tapered Iso board
- 1.5 inches of Progressive Materials SF 4228 Series Spray Polyurethane, ProPoly Foam
- 2 coats of Progressive Materials LS 2200 Series Silicone roof coating, ProPoly Sil, to achieve 20 mils thickness
- Sesco Snow White granules were embedded in the top coat as the final step
- The entire system was installed to achieve an average R-value=40

Because of past issues with drainage, the slope in the tapered roof system was added to facilitate run off. In addition, the roof has more than 150 penetrations which in the past proved hard to seal. The SPF system solved this problem and was also successfully used up all parapet walls to seal failing wall flashings.
