White High Solids Silicone over Metal

SILICONE ROOFING SYSTEMS

Roof Size
125,000 square feet

Substrate
Metal

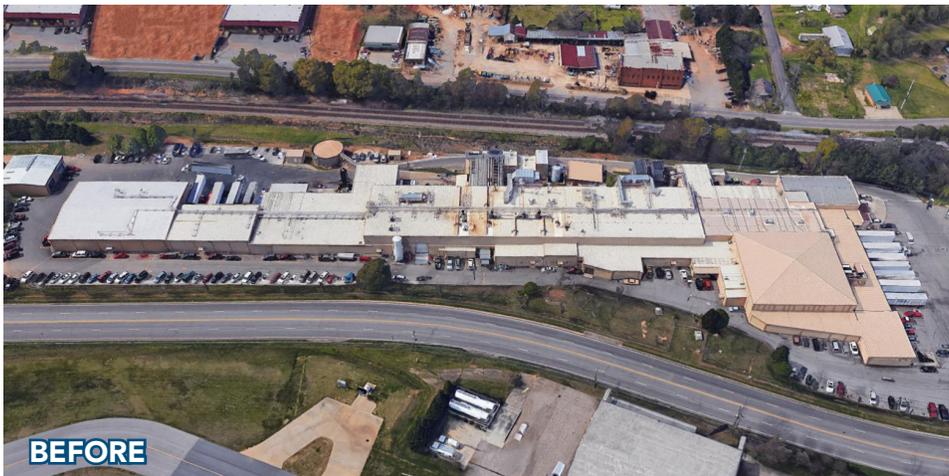
For over 7 years, the Georgia-based meat processing plant has been dealing with major roof issues including over 70 leaks! The roof was riddled with holes, worn areas, and flashing failures that allowed water into the building. As a food processing company, health and safety concerns are a top priority for the plant. If rain water or outside contaminants got inside the building and on the food, the whole batch could be considered contaminated. The plant needed a watertight solution to keep health and safety codes up to date.

The contractor was able to completely restore this roof in only 3 weeks. Using a slim, 10-man team, they gave the roof 20 years of new life in just a few easy steps:

1. First, the team repaired any damage to the roof and cleaned the roof, prepping it for primer and silicone.
2. After this, the team applied PM's P-130 rust inhibitive primer to any rusty areas. Although unnecessary on most metal roofs, P-130 is imperative to slow the rust erosion once it's started.
3. Next, the team used PM's FG 401 to help repair any flashing and patch any seams.
4. After this, they used HS 3201 silicone for the top coat to offer maximum UV reflection to the roof's surface.
5. Finally, they used PM's PG 700 and PG 750 to offer a slip resistant and easy to see walkway to the roof top. This walkway helped lead any facility maintenance personnel right to the mechanical units on the roofs, while greatly reducing the chance for slipping.

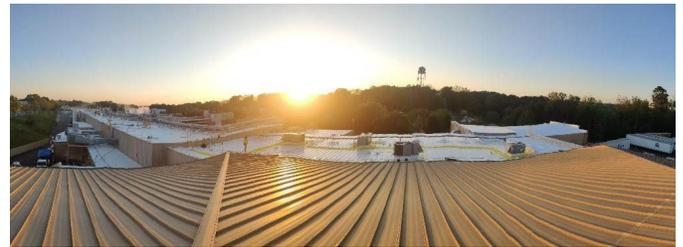
This large building is home to the largest fajita meat processing plant on the east coast. Responsible for processing over 250,000 pounds of chicken a day, this plant is imperative to the country's food supply chains. After noticing leaks in the roof and extreme temperatures that were hard to manage, the building owner decided it was time to give the roof a restoration.

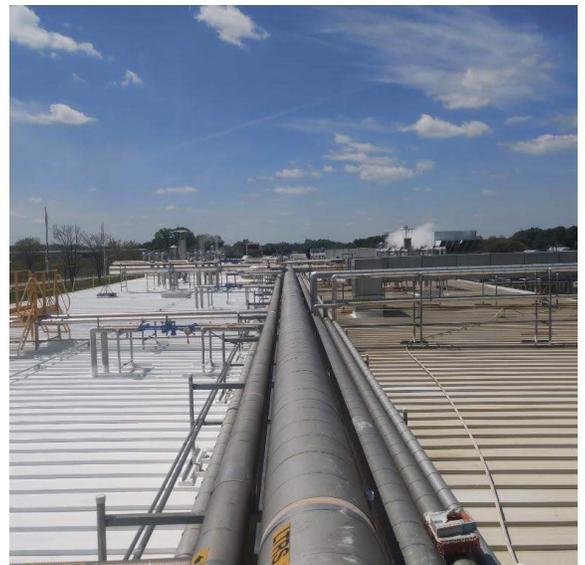
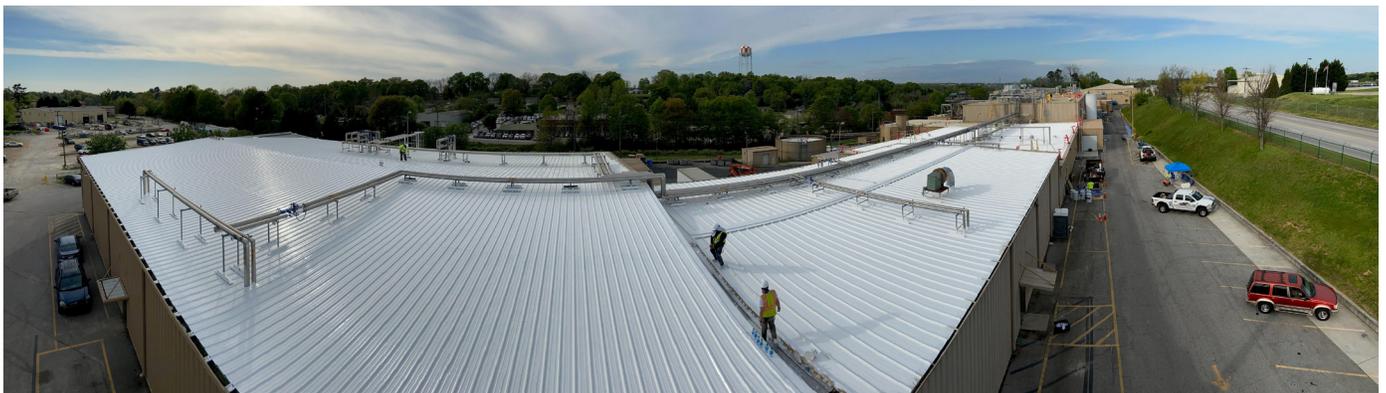
Another benefit to the building was the new walkway foot traffic lanes applied onto the roof. These silicone walkway paths will greatly reduce the chance someone falls while on the roof. Additionally, they will cut down on wear and tear on the roof. Consistent foot traffic can be hard on silicone over time, so having these walkways installed will increase the overall life of the roof.
