Manufacturing Continues During Restoration

SILICONE ROOFING SYSTEMS

Roof Size
70,000 square feet

Location
Waco, TX

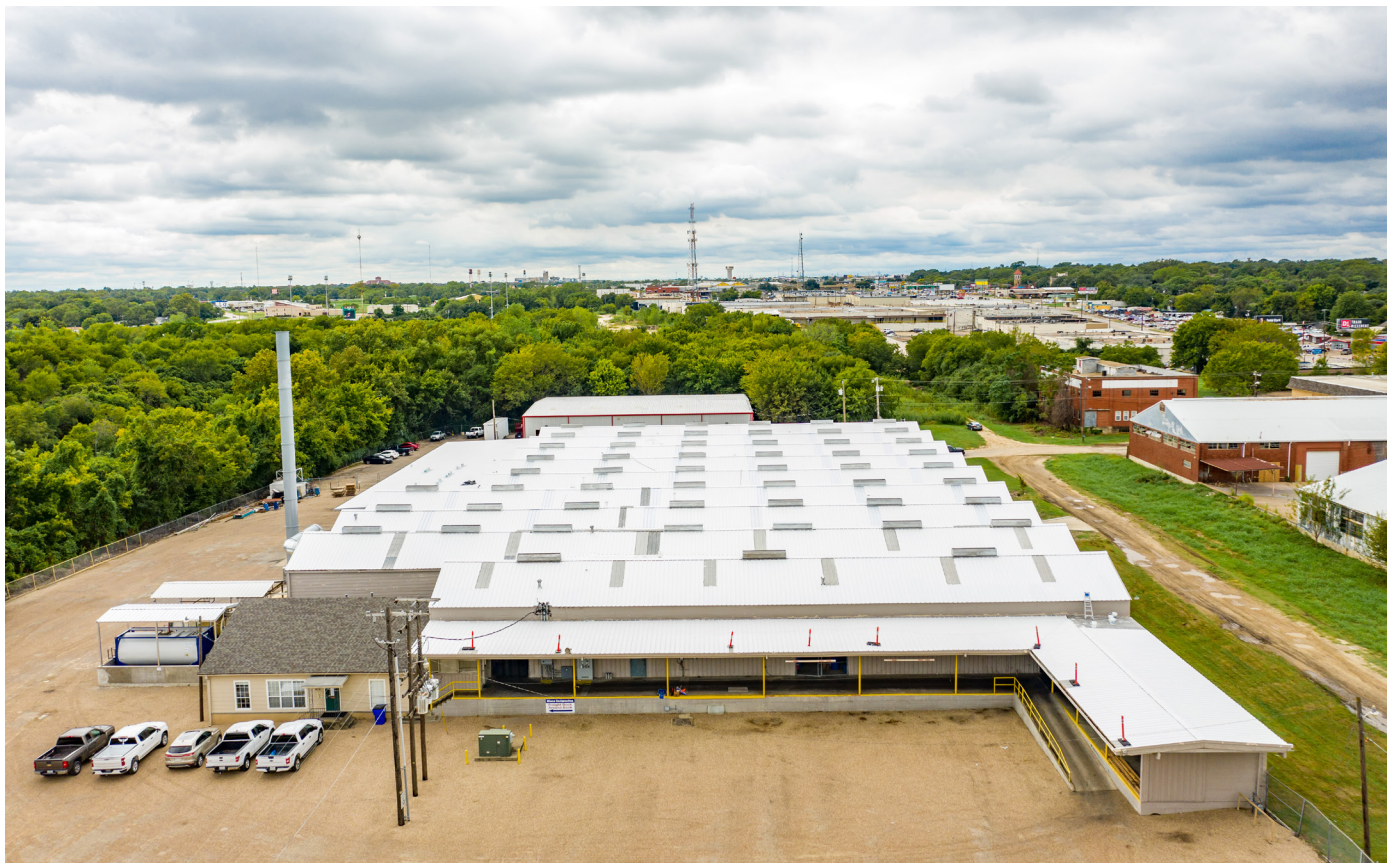
When this Texas-based glass manufacturer noticed multiple roof leaks, their first concern was whether or not they would have to shut down their plant while the new roof was removed and installed. A major concern for most manufacturing facilities is cleanliness and dryness. Production of high-quality glass depends on a clean facility, free of any unwanted particles from the fabrication process. If their roof would have been removed and replaced, production would have been halted for as long as the roof was missing. Thankfully, **a PM silicone roof restoration eliminates the need for a roof tear-off**, eliminating the need to halt any production!

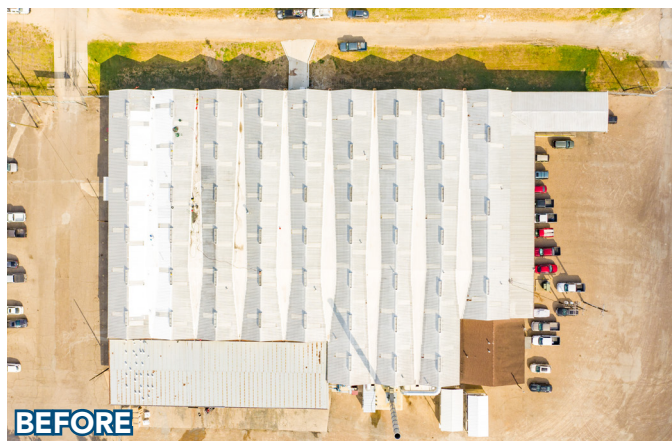
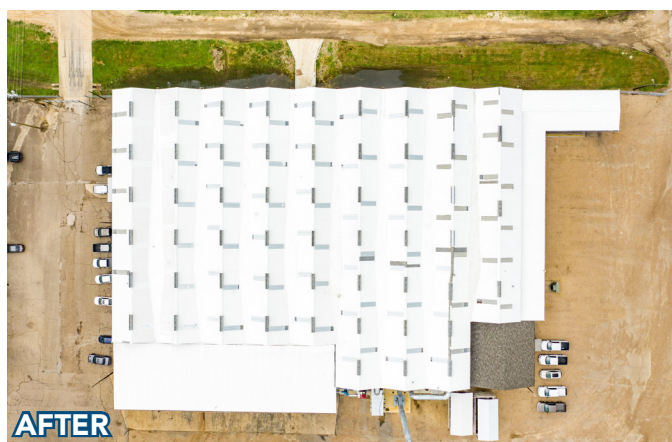
Rust is one of the most common occurrences on a metal

roof. As seen on the before image below, rust had already started overtaking this facility's roof. Another issue with metal roofs are their seams and bolts. Fluctuating temperatures and ground shifts cause bolts to loosen over time. As the bolts loosen, seam gaps become larger and water begins to enter the faulty areas. This is exactly what happened on this roof causing multiple leaks within the facility.

1. First, the team powerwashed the roof ensuring the existing substrate was free of grease or debris, preparing it for coating.
2. Next, the team applied PM's P-160 Rust Inhibitive Primer to any rusty areas on the roof. Primers are not typically needed with PM silicone roof restorations, but since rust can cause lasting damage to metal surfaces, it's best practice to use P-160. This almost completely halts rust growth on metal substrates.
3. Finally, the team applied HS 3201 to the entire roof.
