Constant Leaks Led to Constant Shutdowns...

Until PM Silicone Waterproofed the Plant

SILICONE ROOFING SYSTEMS

Roof Size
85,000 square feet

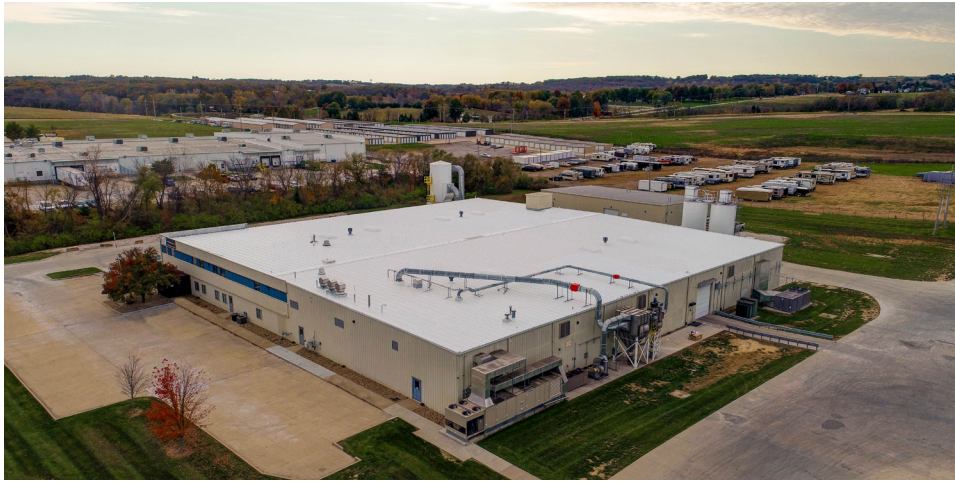
A leaky roof for a manufacturing facility is a major problem. For a food processing facility, it is even worse. To ensure the cereal products were not contaminated, **Cereal Ingredients had to shut down the entire facility every time the roof leaked.** As a facility with two buildings and six food processing lines, constantly shutting down and starting up production was not feasible.

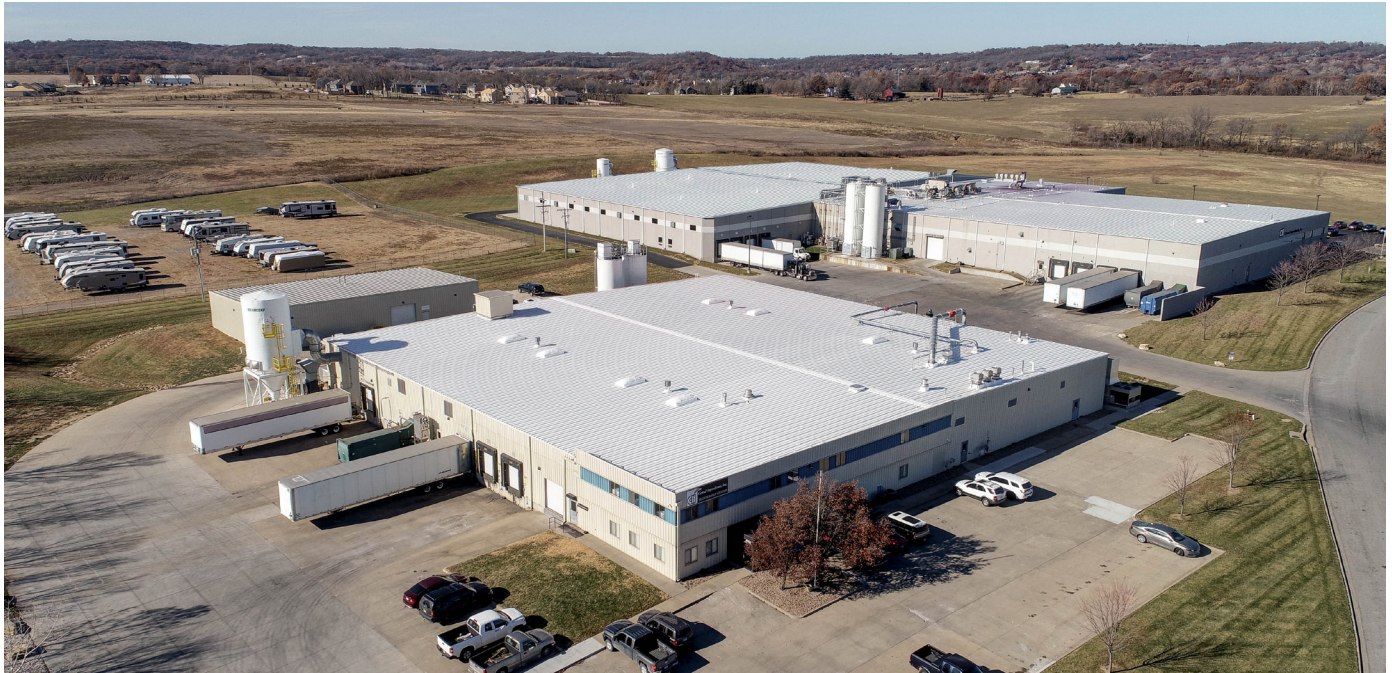
Working in tandem with one of our Certified Licensed Contractors (CLA), the PM team was able to identify all leaky areas and offer Cereal Ingredients a lasting solution:

1. First, the team powerwashed the entire roof.
2. Next, the team spot-applied PM's P-130 Rust Inhibitive Primer to any rusted areas on the roof. Primers are not typically needed with PM silicone roof restorations, but since rust can cause lasting damage to metal surfaces, it's best practice to use P-130 on rust as it almost completely halts its growth.
3. After applying P-130, the team treated all seams and fasteners with PM's FG-401 Flashing Grade Silicone.
4. After prepping the seams, the team applied PM's 3201 White High Solids Silicone Roof Coating.
