# Surface-Leveling Silicone to the Rescue

## Louisiana Church Save Big with a PM Restoration

**Roof Size**  
3,300 square feet

**Substrate**  
Gravel Built Up & Metal

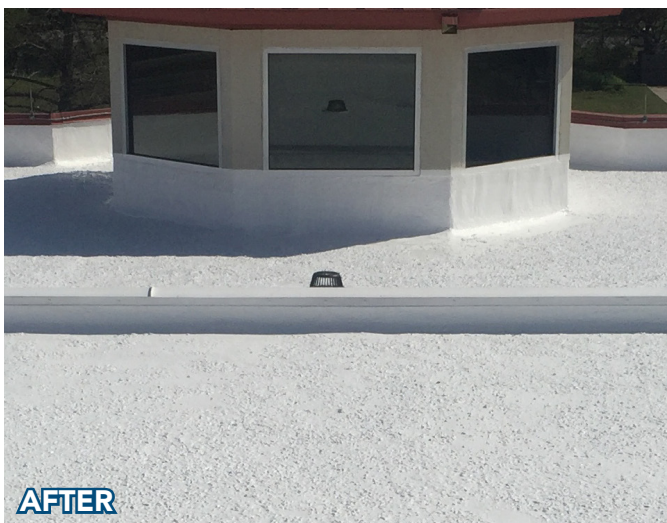
After decades of wear and tear, the church had begun noticing leaks in their building. Like any roof leak, as time went on, the leak began to spread and got bigger and more concerning. To make matters worse, the leaks were centered over the church's musical equipment, posing another costly concern to the church.

After getting in contact with one of PM Silicone's Certified Licensed Contractors (CLA), the Church decided a roof restoration was the smartest move. Given that the roof had gravel on it, PM's Surface-Leveling Silicone (SL 800) became the proposed solution. SL 800 is a cheaper silicone that goes on before the top coat to fill in the cracks and crevasses in the gravel. It still gets great adhesion and is completely watertight, but it is not as UV protective and would break down more quickly without a top coat. This is used to ensure a fully seamless membrane without the cost of applying the top coat in bulk. SL 800 can be poured on more generously to fill in all the gaps in the gravel without drastically raising the final project cost.

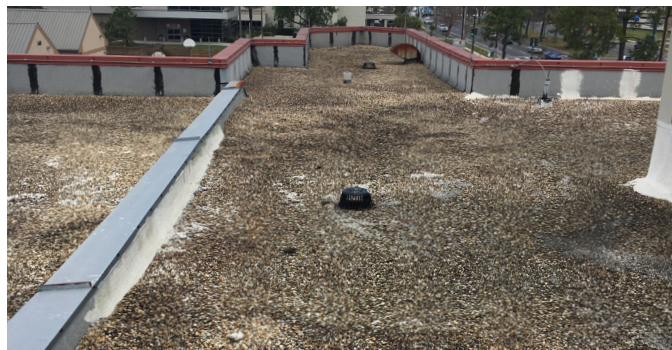
### 1) Clean Up

To begin the process, the CLA first needed to clean the roof. In order for the primer and silicone to adhere, the roof was scraped clean. This entailed removal of all loose rocks and debris. The removal of these objects is crucial to allowing the primer to offer maximum hold. When dealing with a roof with this much wear and tear, trying to get to a clean starting point is one of the most important steps in the process.

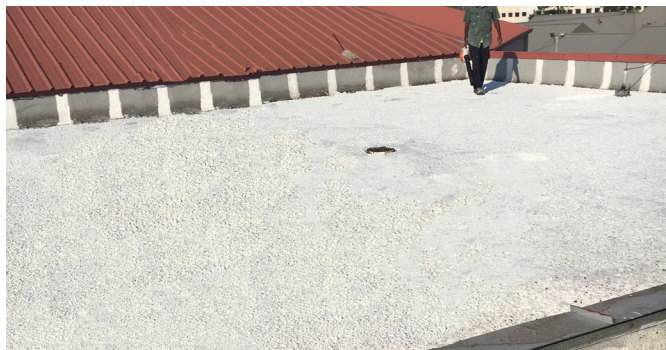
### 2) Priming the roof

After the CLA thoroughly cleaned the roof, it was time to put down the primer. On most silicone jobs, primers aren't necessary. On gravel roofs, however, PM's P-160 is important due to the amounts of mini crevasses on the roof. The primer works its way into the cracks and crevasses of the gravel, offering the surface-leveling silicone stronger adhesion. On gravel-built up roofs it's always important to hit every gap.

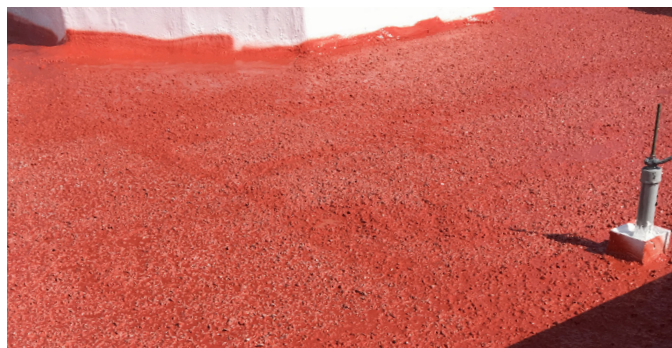
### 3) Self-Leveling Silicone

Application of SL 800 is the main differentiator between gravel built-up roofing jobs and your typical restoration jobs. This silicone is applied generously to penetrate all gaps in the gravel and makes the bumpy surface able to be coated with a silicone top coat. You should note that SL 800 does not fully level out the roof. You will still have a bumpy surface from the gravel. It will be level enough, however, for the top coat to hold strong for years.

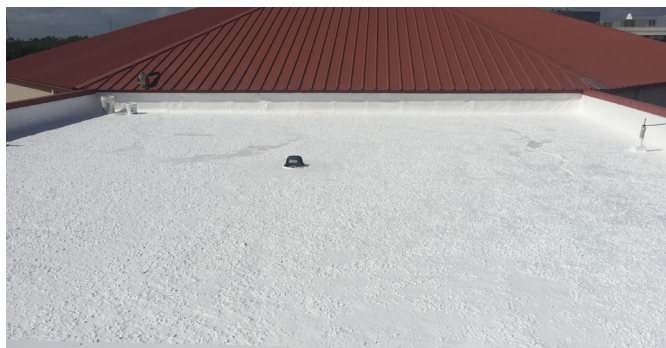
### 4) Silicone Top Coat

After the roof was cleaned, primed, and leveled, it was time to apply the top coat. The reason you need a top coat over SL 800 is because the top coat is more UV stable and more durable. Additionally, the top coat is usually white which keeps energy costs down in the building. PM's white 3201 top coat silicone reflects up to 88% off the sun's UV rays making it the perfect roof coating for the hot Louisiana climate.
