PROTECTING THE HOOSIER GYM PRESERVING A STATE TREASURE

Knightstown, IN

Project Profile

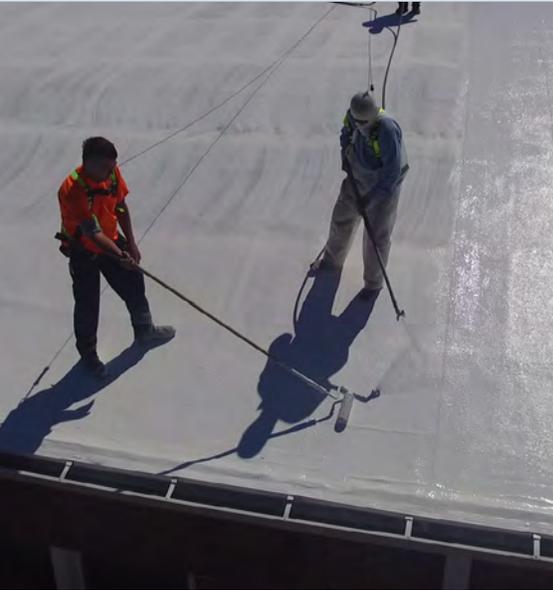
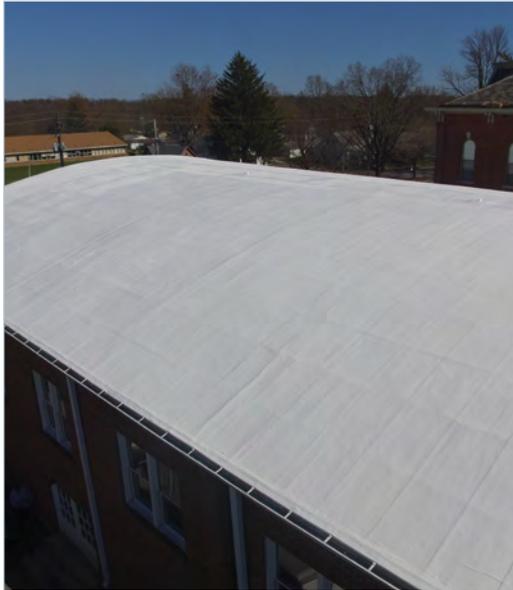
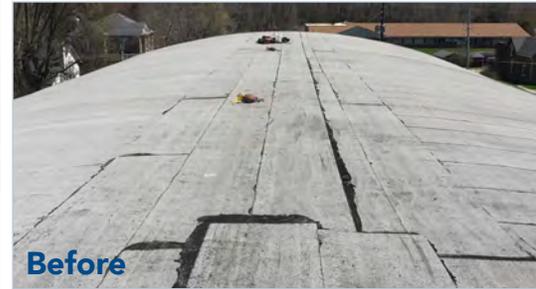
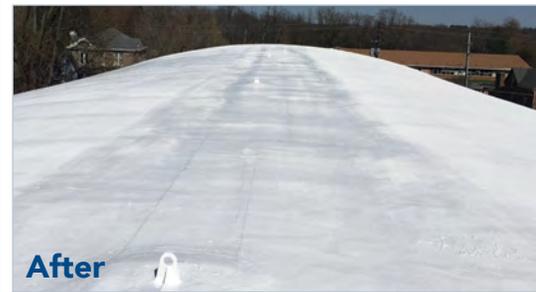
The roof was coated using a combination of spraying and rolling the coating to ensure all seams and crevices were completely filled and sealed. This also allowed the contractor to ensure the coating was applied at the correct thickness.

- Installed anchors at the peak of the roof to tie off workers and ensure safety while working.
- Power washed the Modified Bitumen roof to remove all dirt and grease stains.
- Applied an extra layer of silicone coating to any damaged seams to ensure no leaks would appear.
- Coated the field of the roof with two coats of 100% silicone coating.
- Coated a curb on the west side of the building to completely encapsulate the roof.
