Roofing During a Supply Chain Crisis

10 Months Saved by Using PM Silicone

Roof Size
55,000 square feet

Location
Miami, FL

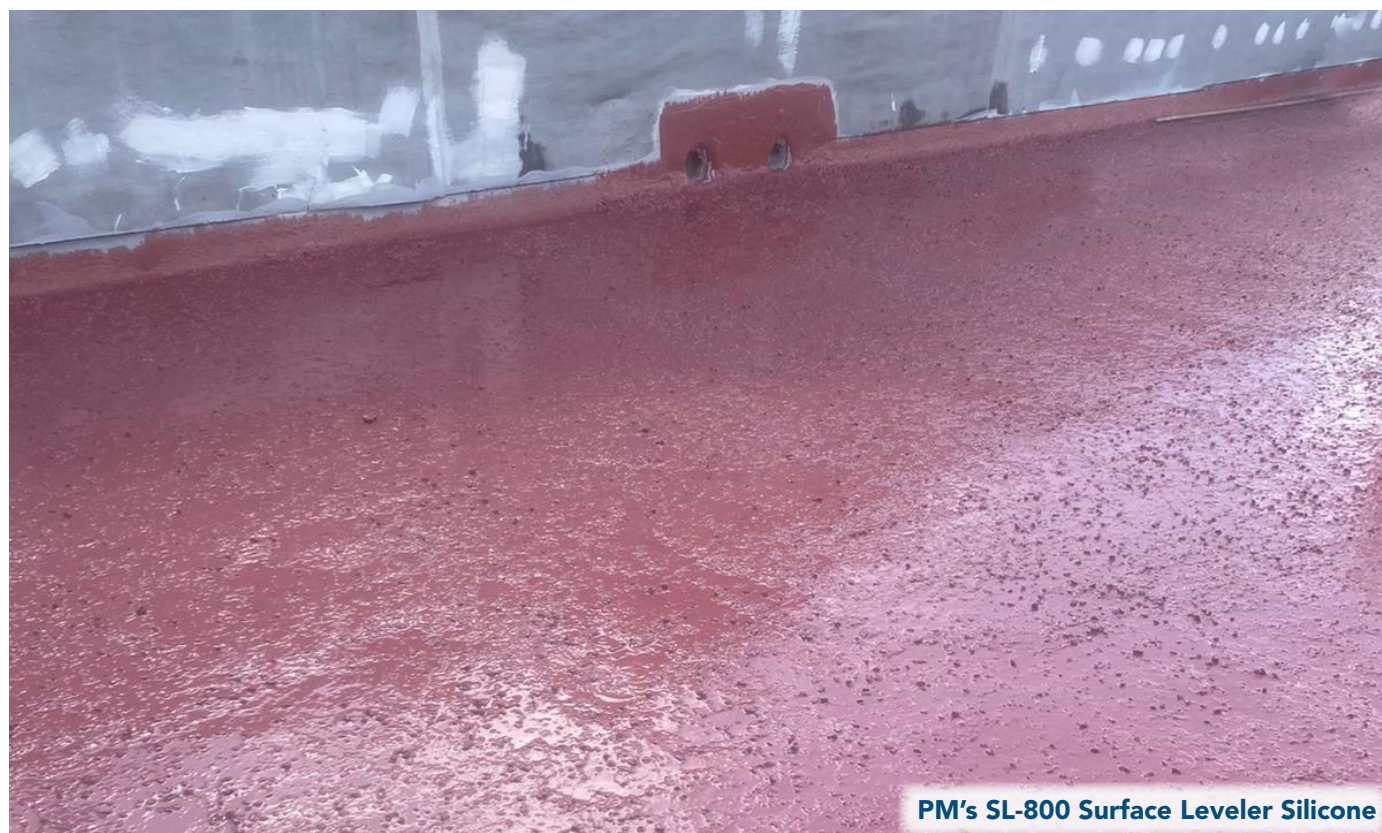
PM's SL-800 Surface Leveler Silicone

For years, there was no cost-effective roof restoration system for gravel built up roofs. Installing silicone would require such thick - to get into all the cracks and crevasses of the gravel - that it has always been cheaper to simply replace the roof. Thanks to PM Silicone's SL-800, however, things have changed. Through extensive research & development, PM created a formulation of silicone that has great adhesion without breaking the bank. This layer acts as a buffer between the roof and the silicone top coat to ensure cost-effective adhesion without sacrificing UV stability and overall durability. Here is how the system was installed on this roof:

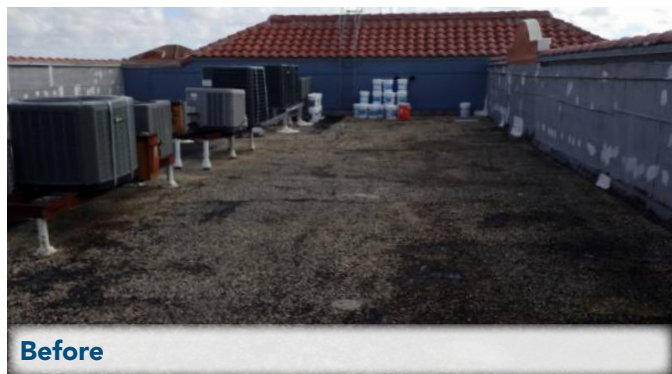
Before

The location of this building was the key issue. Between the high level of UV rays beating down on the roof, the salty air, and the immense rain that can come at any moment, Miami is hard on roofs. Waiting 10 months for single ply materials to arrive could have been detrimental to the building. If the roof failed before the single ply was available, the owner would be forced to sit and watch while the damage progressed. Thankfully, PM Silicone has been fully stocked throughout the pandemic and was able to offer a solution for this owner's gravel roof.

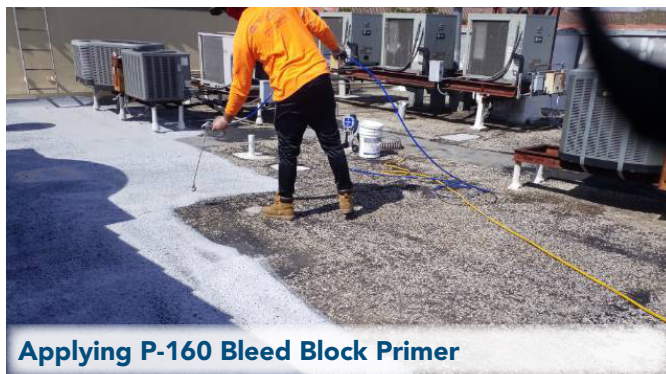
Applying P-160 Bleed Block Primer

1. The team powerwashed the roof to remove all loose rocks, grease, or debris.
2. Next, the team used PM's P-160 primer to offer even better adhesion and prevent the roof from yellowing.
3. SL-800 went on next, covering all of the remaining gravel and preparing the roof for the final top coat.
4. Finally, HS-3201 was applied to give the roof a UV stable, seamless membrane.

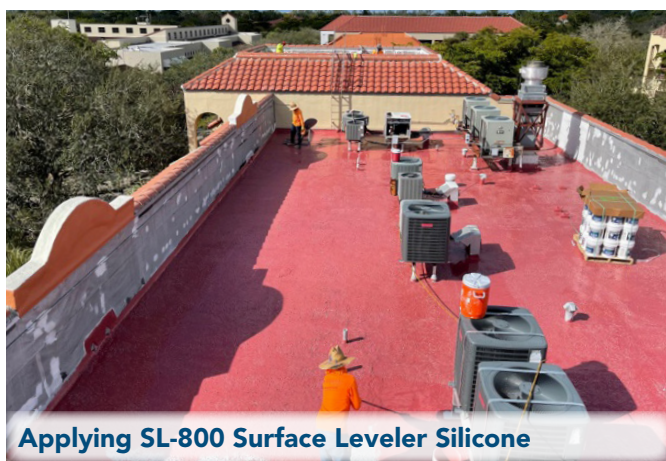
Applying SL-800 Surface Leveler Silicone

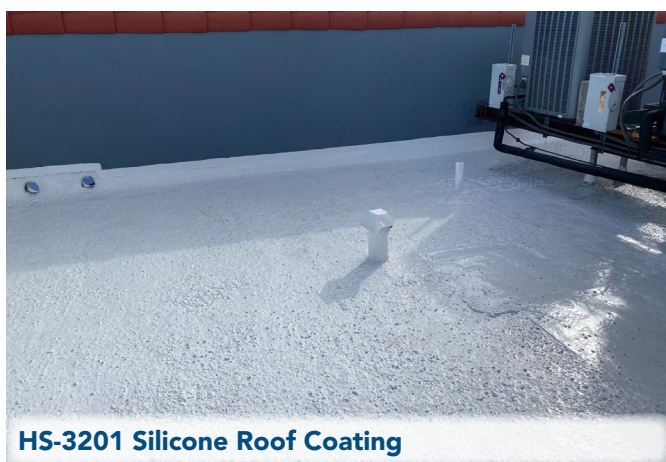
HS-3201 Silicone Roof Coating
