RCR SYSTEM PROTECTS SENSITIVE OPERATIONS WATERPROOFING 1.1 MILLION SQUARE FEET

When Interior Climate Matters Most:

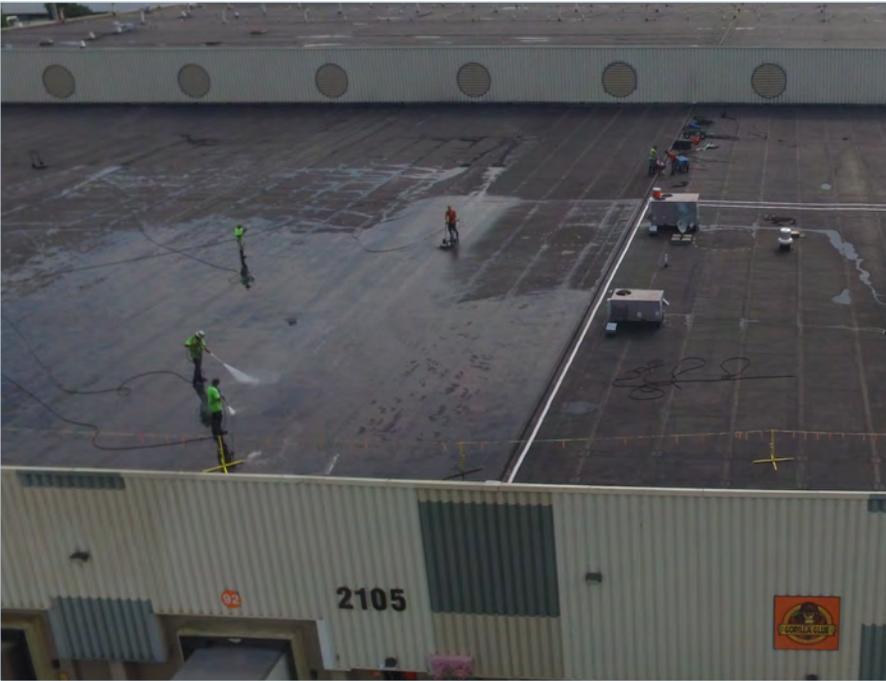
The entire roof had to be powerwashed to clean off a black substance present on many EPDM roofs.

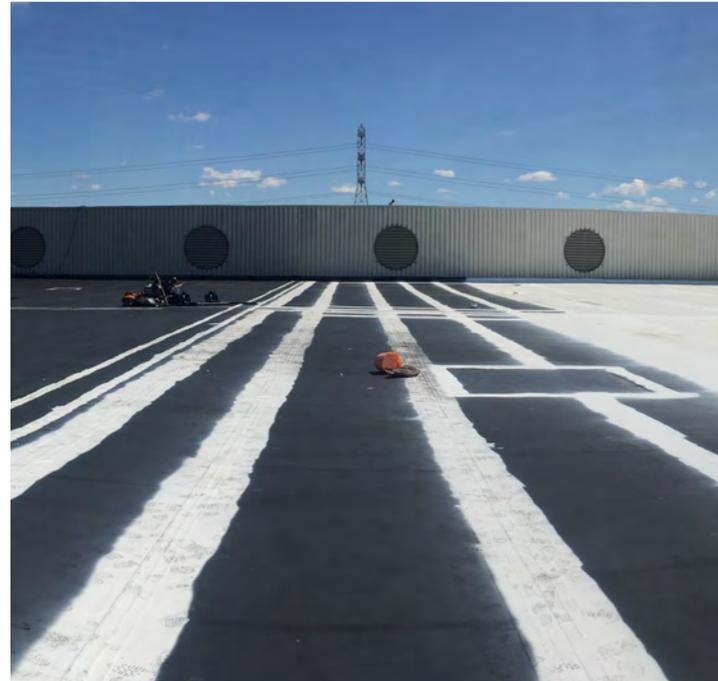
A halfway-coated black roof illustrates the benefits of a reflective roof, as you can see the difference in brightness on the wall.
