## Roof Coating Restoration Over Gravel BUR

Surface Leveling Coating for a Smooth Roof Surface

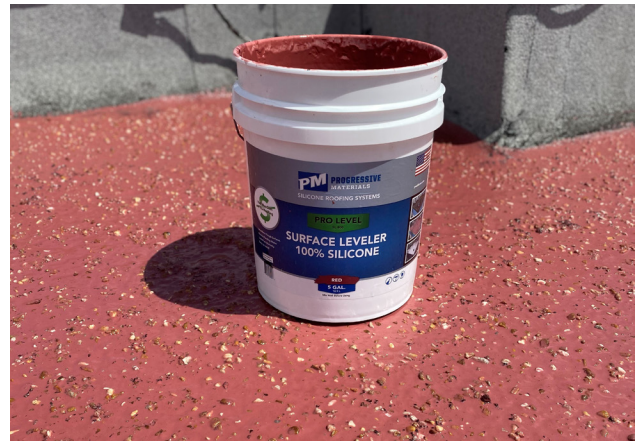
SL 800 Surface Leveling Coating is not designed to create a perfectly level surface but it creates a much smoother surface to which our roof coating can be properly applied.

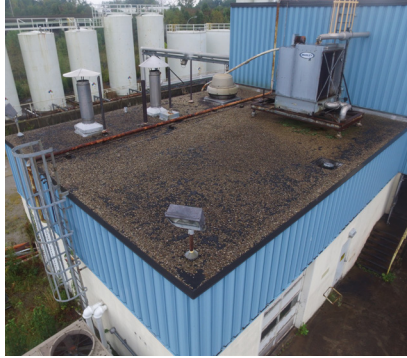
1. Original gravel BUR roof surface.

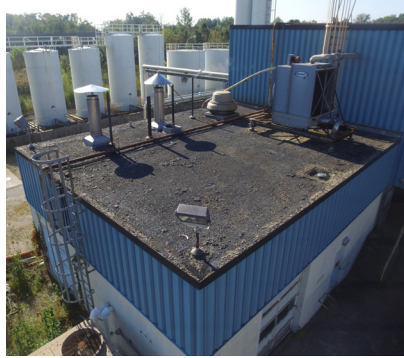
2. Remove loose rock.

- Inspect existing roof system
- Remove all loose gravel
- Power-wash roof surface
- Perform a moisture survey and replace all wet material
- Identify and repair any problematic flashings and sheet metal
- Apply P-160 Bleed Block Primer
- Apply SL 800 Surface Leveling Coating
- Apply HS 3200 Silicone Roof Coating
- Inspect roof to ensure compliance with PM specifications

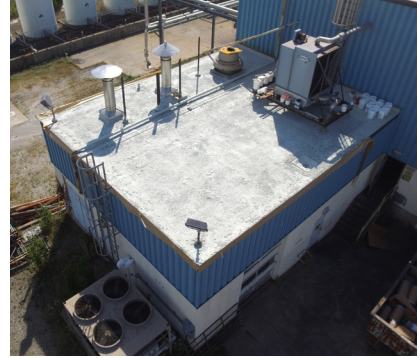
3. Apply P-160.

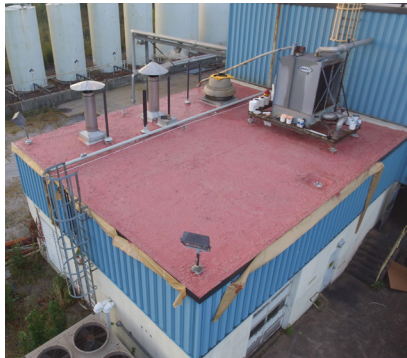
4. Apply SL-800.

SL 800 is designed to be more free-flowing than our roof coating, allowing it to migrate to the low parts of the roof and fill every crack and crevice. This complete coverage allows for a smooth surface and proper waterproofing performance.

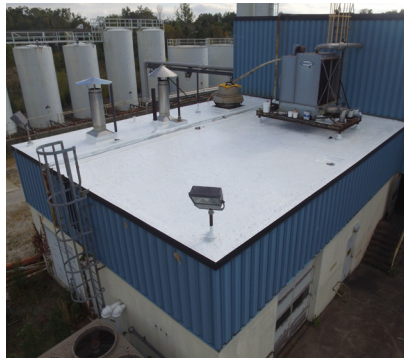
5. Apply HS-3200.

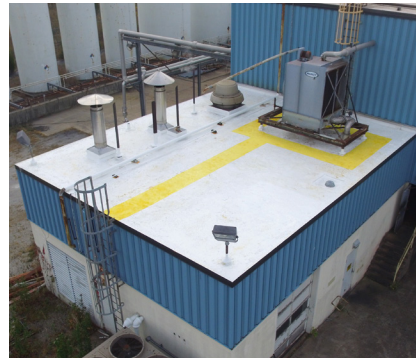
6. Apply PG-700 system (optional).
