## CONTRACTOR MARVELS AT FIRST USE OF SILICONE RESTORATION SYSTEM

Lynnwood, Washington

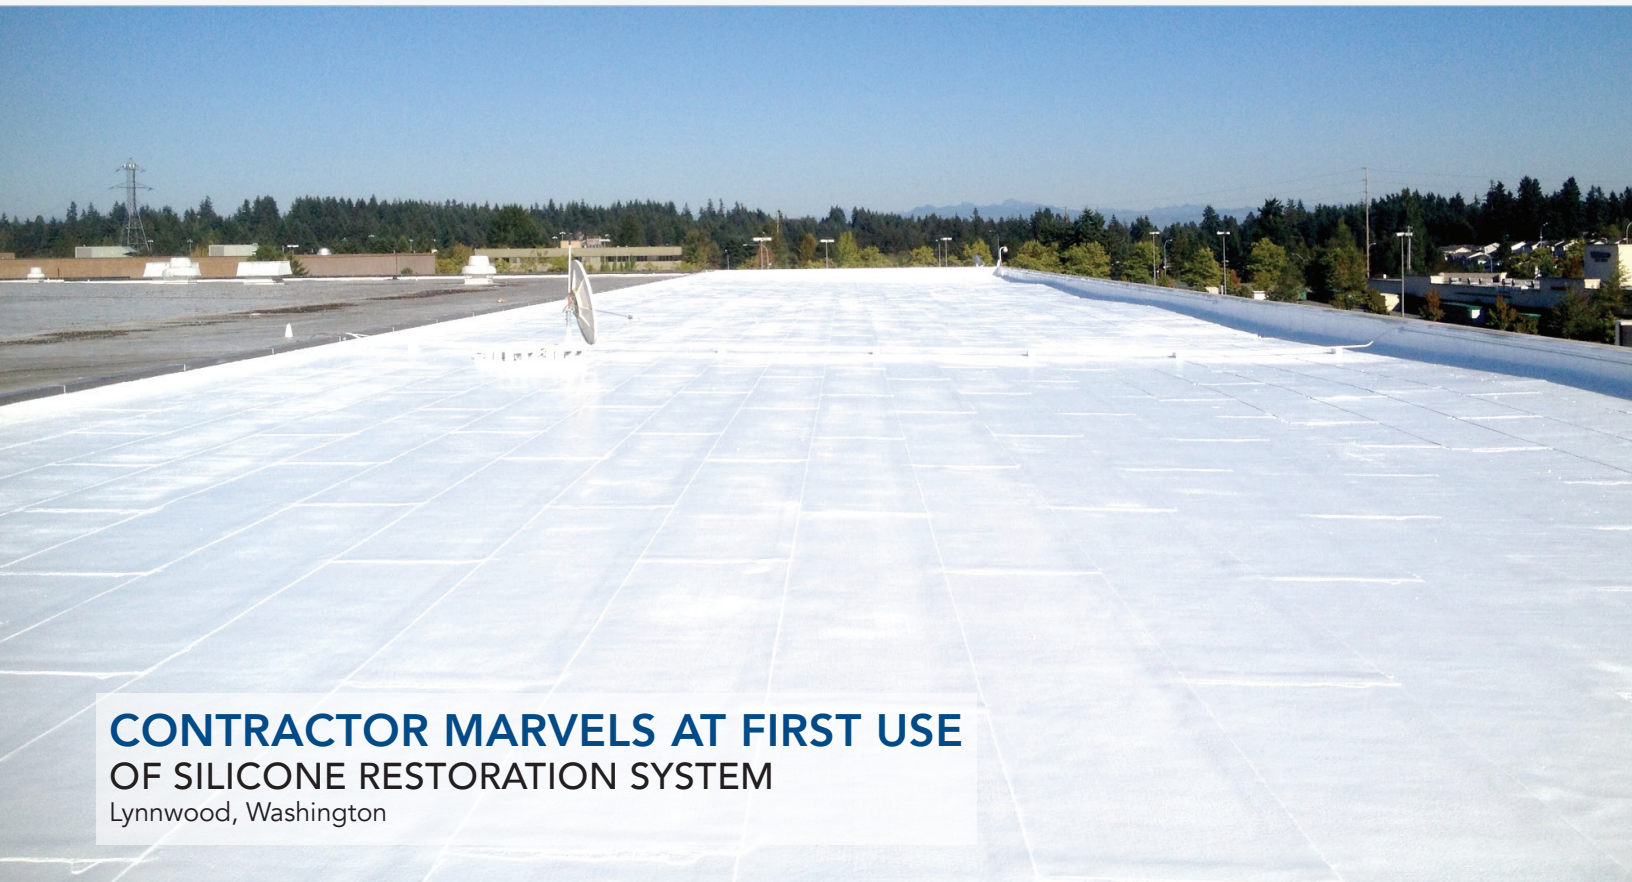
The Macy's existing roofing system was approximately 20 years old. Areas of blistering and significant granule loss from the cap sheet were apparent. Roof leaks were reported in the building and a thermal imaging of the roof showed wet areas in the system. Any significant rainfall resulted in leaks and the need to relocate merchandise.

Cool Roofing Systems (CRS) was the contractor hired to restore 18,328 square feet of the leaking roof. By using

Progressive's HS 3201 silicone roof coating restoration system (RCR) they were able to repair the roof without a complete tear-off.

**Dealing with the Damage:** CRS took core samples in various locations where the thermal imaging tests showed possibility of moisture in the roof system. These areas were marked, cut through, and then patched back into place using silicone coating materials and polyester reinforcing fabric.

- Power wash the existing BUR roofing system.
- Damaged areas were 3-coursed with silicone and polyester reinforcement.
- All wet areas were removed and replaced.
- All laps were sealed with 25 mils of silicone coating.
- Entire roof surface received 40 mils of silicone coating.

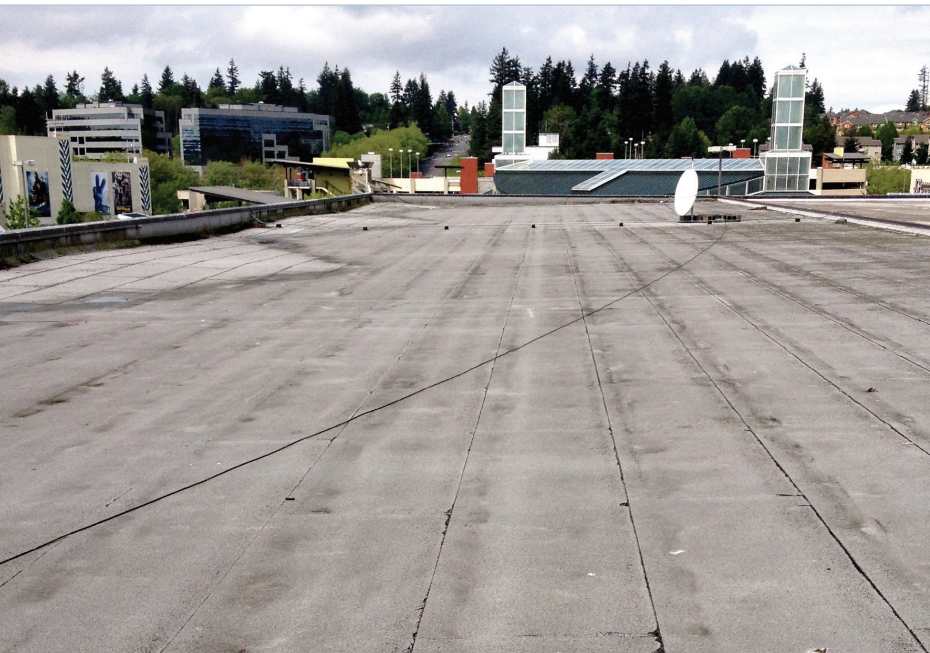
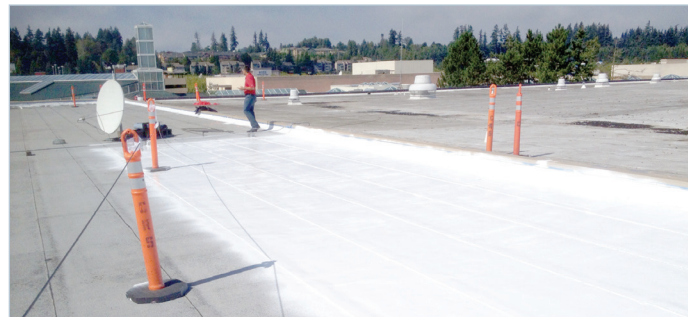
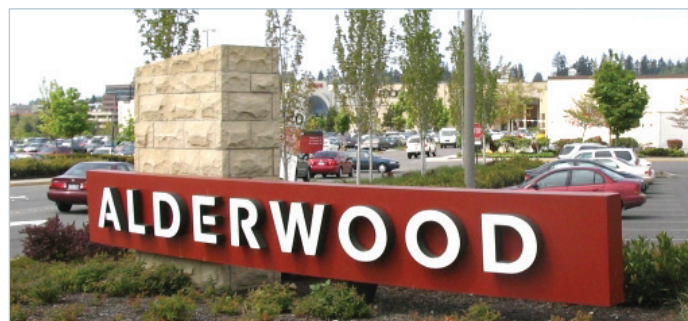
The Macy's roof in Lynnwood, Washington showed severe signs of deterioration and water damage. After patching and repair work was completed, the Progressive RCR process provided a waterproof, sustainable system that pleased Macy's facility management.
