ROOF COATING RESTORATION (RCR) OVER GRAVEL BUR SURFACE LEVELING COATING FOR A SMOOTH ROOF SURFACE

Affordable Roof Restoration:

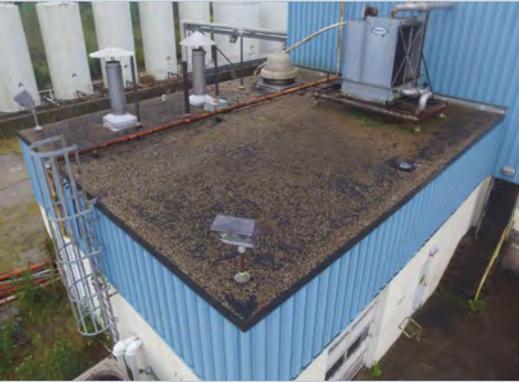
1. Original Gravel BUR roof surface

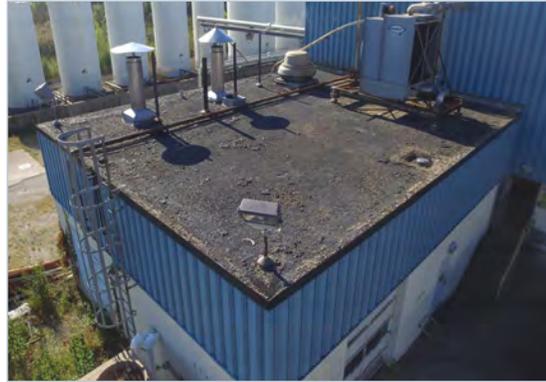
2. Remove loose rock

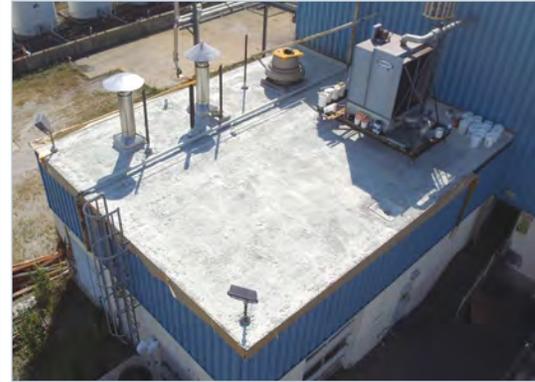
3. Apply P-160 Bleed-Block Primer

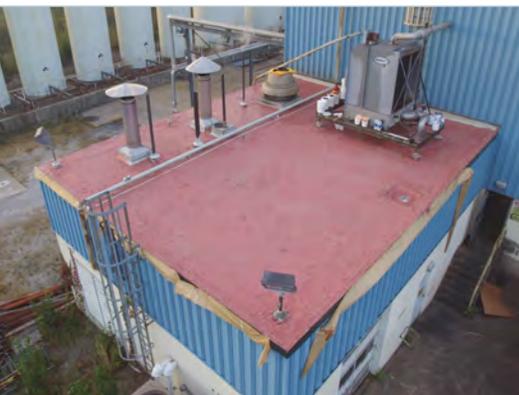
4. Apply SL 800 Surface Leveling Coating

SL 800 is designed to be more free-flowing than our roof coating, allowing it to migrate to the low parts of the roof and fill every crack and crevice. This complete coverage allows for a smooth surface and proper waterproofing performance.

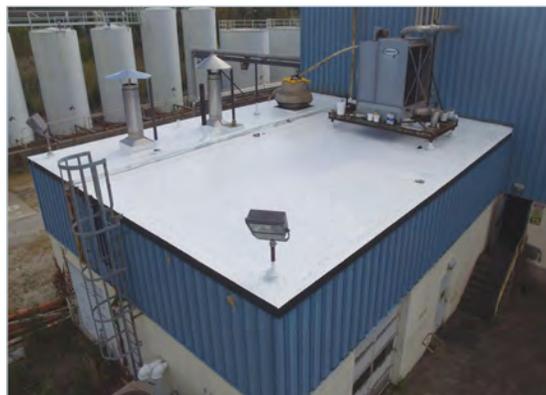
5. Apply HS 3200 Silicone Roof Coating

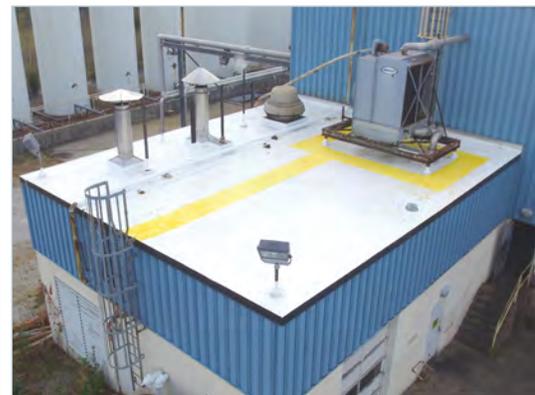
6. Apply Pro-Grip Walkway System (optional)

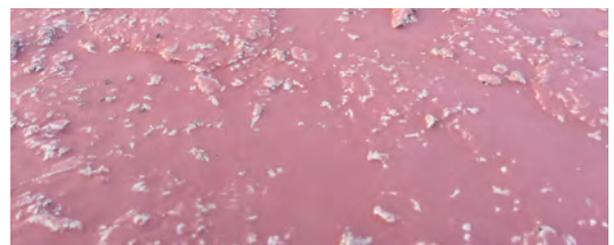
SL 800 Surface Leveling Coating does not create a perfectly level surface – and it is not designed to – but it creates a much smoother surface to which our roof coating can be properly applied
