Affordable Roof Restoration

Roof Coating Restoration Over Gravel BUR

Surface Leveling Coating for a Smooth Roof Surface

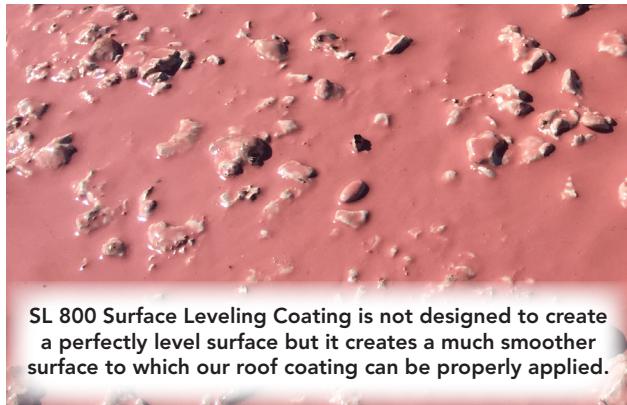
SL 800 Surface Leveling Coating is not designed to create a perfectly level surface but it creates a much smoother surface to which our roof coating can be properly applied.

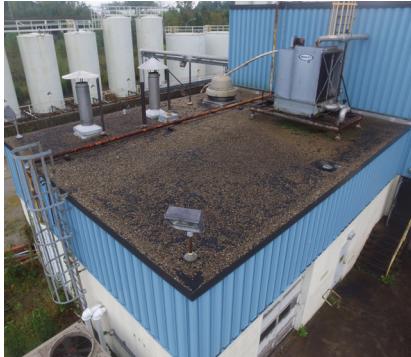
1. Original Gravel BUR roof surface

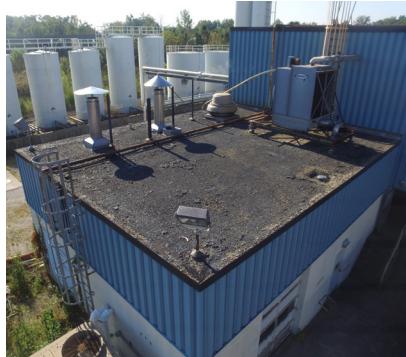
2. Remove loose rock

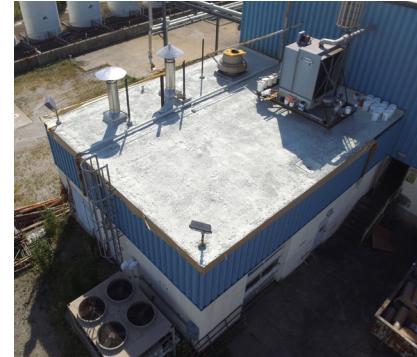
3. Apply P-160 Bleed Block Primer
(Optional)

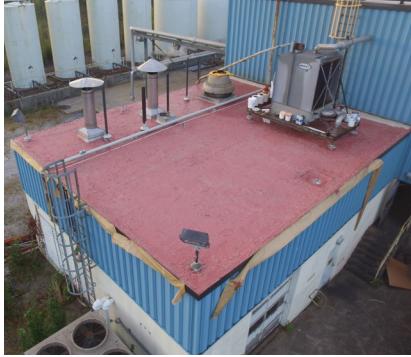
4. Apply SL 800 Surface Leveling Coating

SL 800 is designed to be more free-flowing than our roof coating, allowing it to migrate to the low parts of the roof and fill every crack and crevice. This complete coverage allows for a smooth surface and proper waterproofing performance.

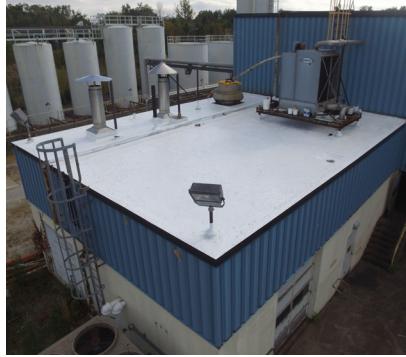
5. Apply HS 3200 Silicone Roof Coating

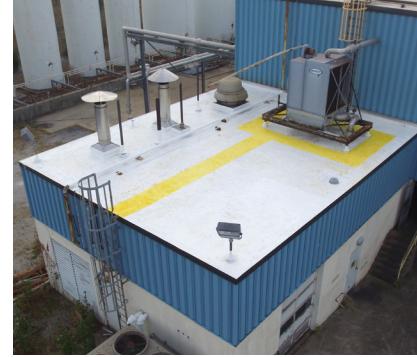
6. Apply Pro-Grip Walkway System
(optional)
